# BOLTED FIELD REPAIR OF COMPOSITE STRUCTURES

J. C. Watson, et al.  
McDonnell Douglas Corporation  
McDonnell Aircraft Company  
P.O. Box 516  
St. Louis, Missouri 63166

Final Report

Repairs were demonstrated on both laminate thicknesses. The 3/16 inch laminate was typical of an AV-8B wing skin. The 1/2 inch laminate was typical of an F-18 wing skin. Three sizes of damage holes were investigated for each laminate thickness: 1.0 in., 2.5 in., and 4.0 in. diameters. Two repair concepts were evaluated for each damage configuration.

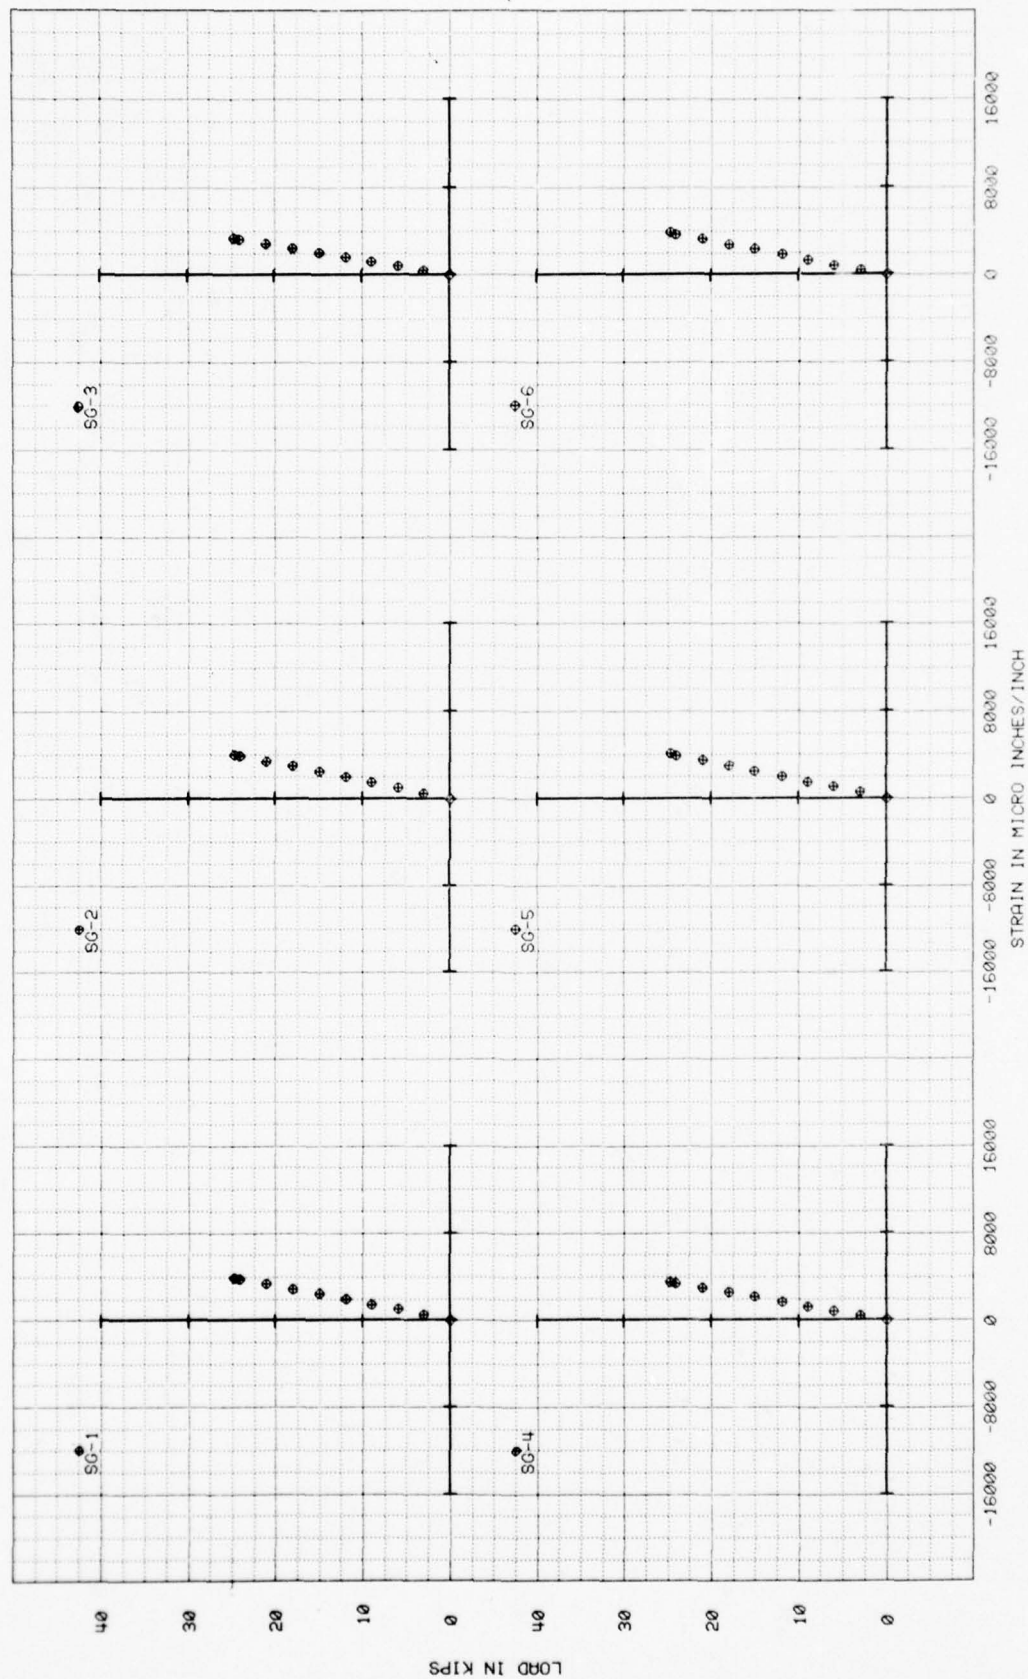
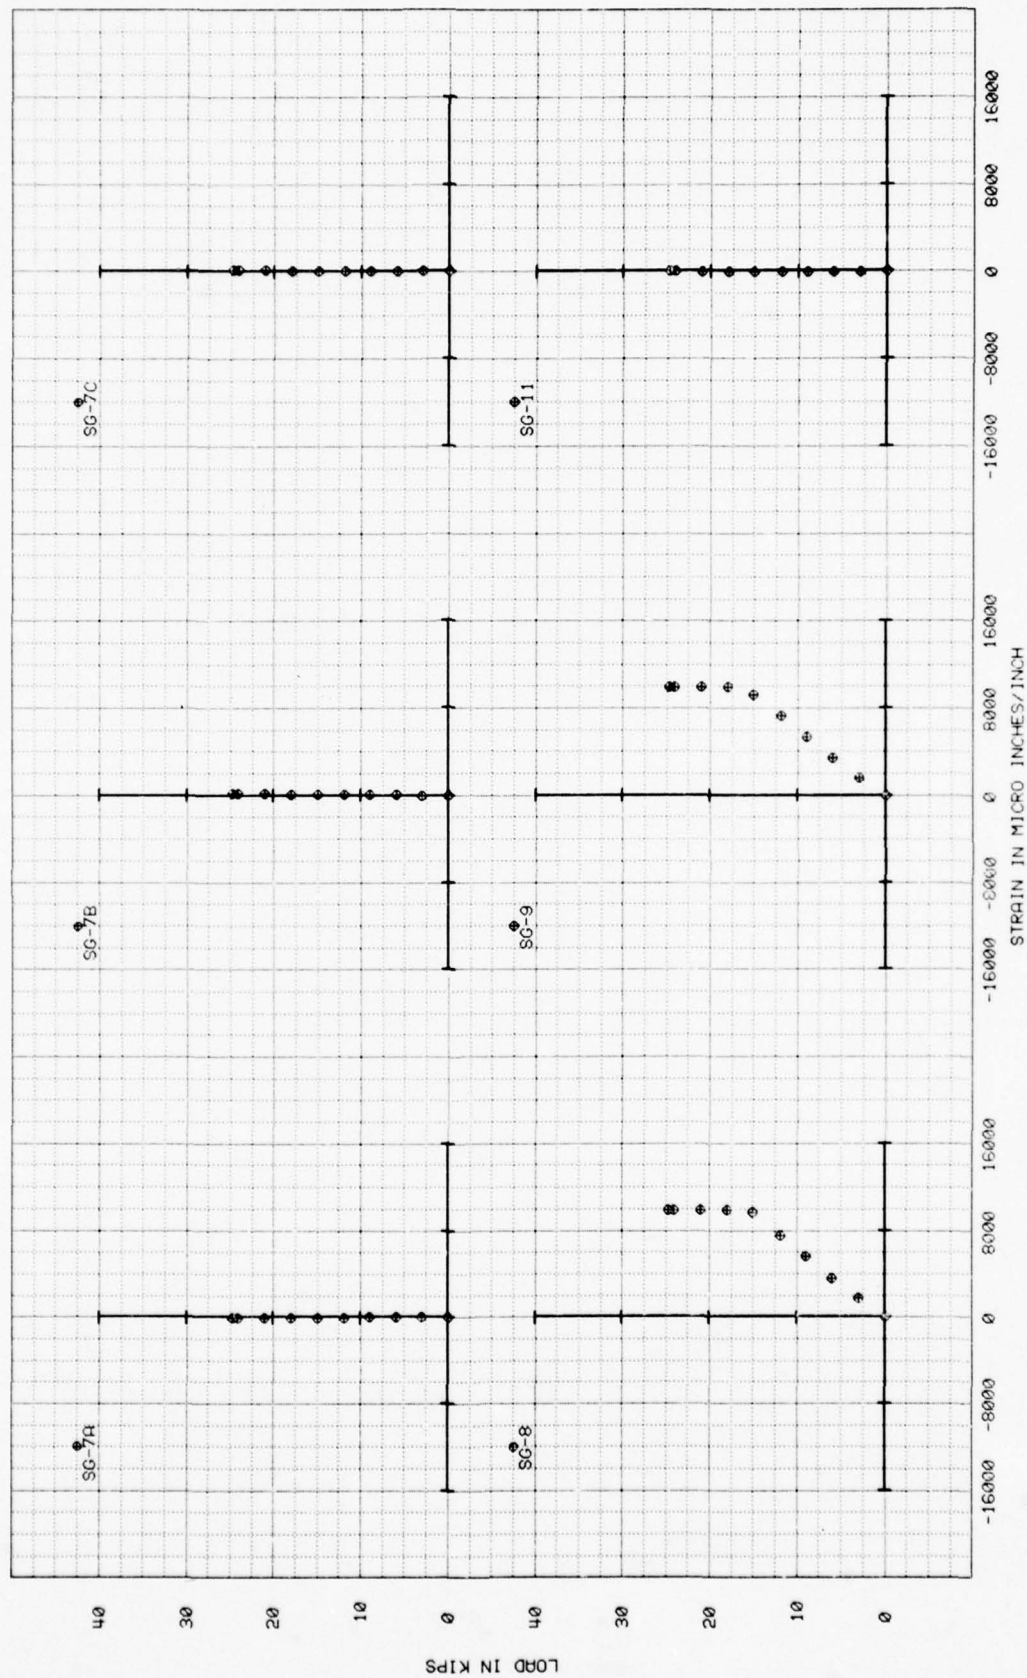
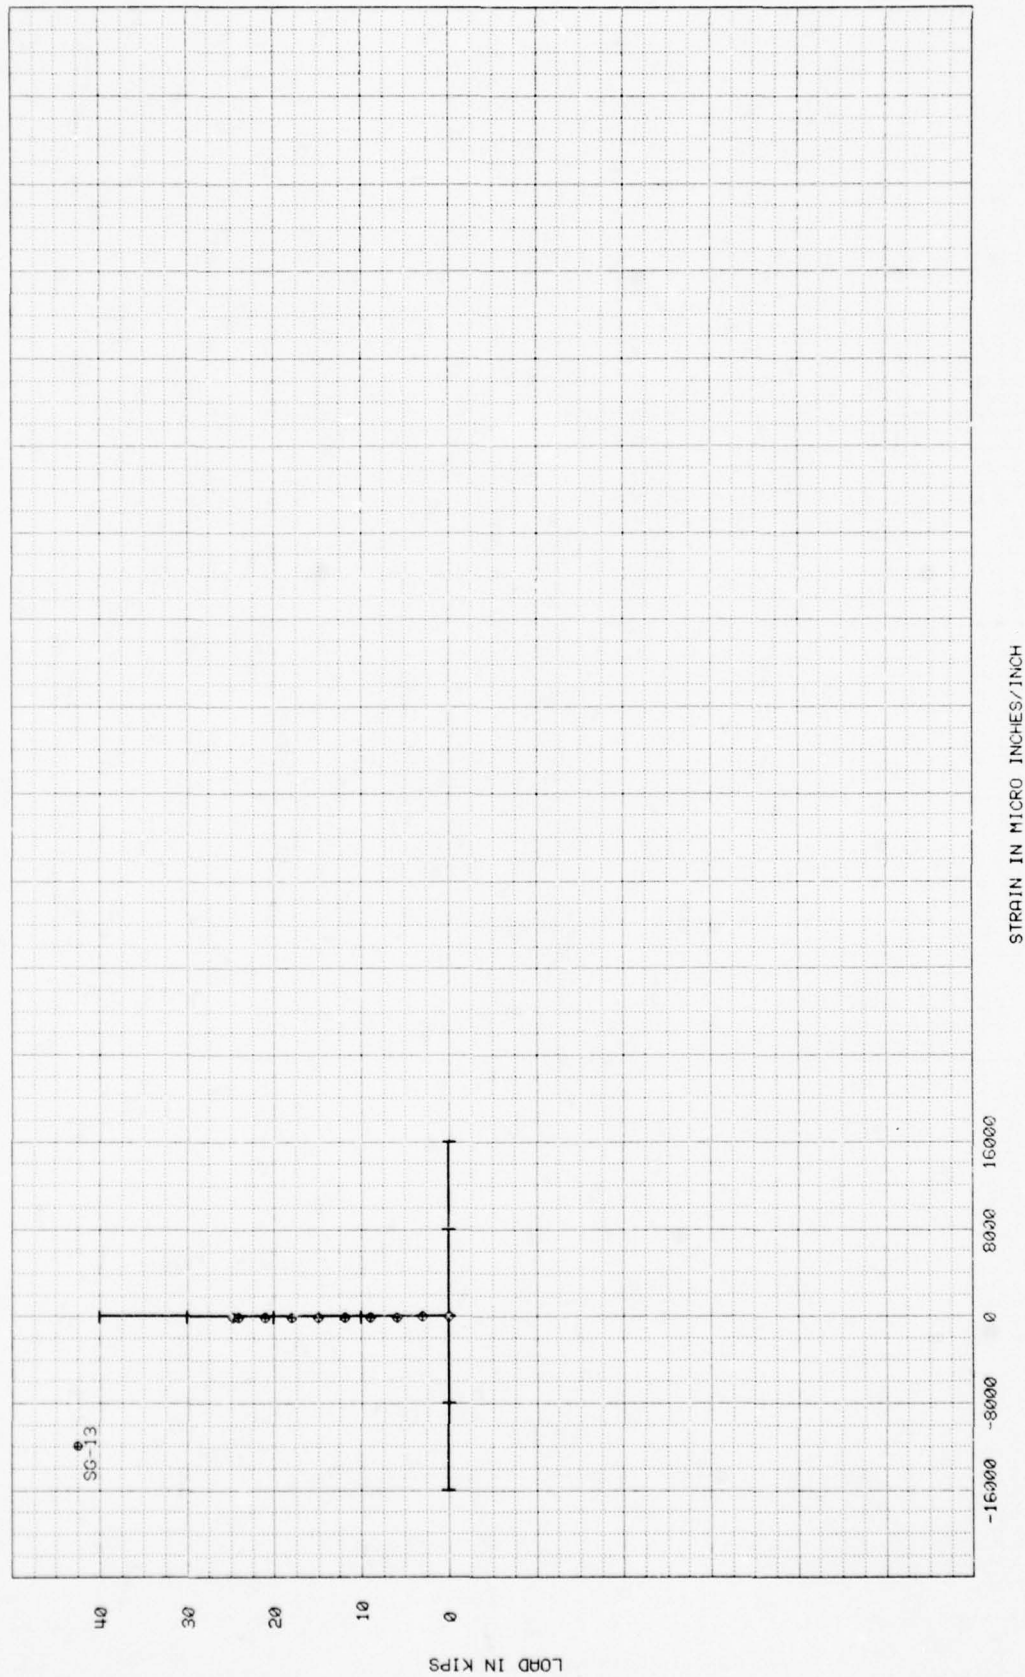
FIGURE B-2 Strain Gage Data 75T060105-1003  
3/16 Laminate 1.0 Dia Damage Hole

FIGURE B-2 Continued Strain Gage Data 75T060105-1003  
3/16 Laminate 1.0 Dia Damage Hole

FIGURE B-2 Continued Strain Gage Data 75T060105-1003  
3/16 Laminates 1.0 Dia Damage Hole

FIGURE NO	TEST SPECIMEN NO	DESCRIPTION OF SPECIMEN
B-1	75T060105-1001	3/16 Laminate
B-2	75T060105-1003	1.0 Diameter
B-3	75T060105-1019 #1	Damage Hole
B-4	75T060105-1019 #2	
B-5	75T060105-1005 #1	3/16 Laminate
B-6	75T060105-1007	2.50 Diameter
B-7	75T060105-1005 #2	Damage Hole
B-8	75T060105-1005 #3	
B-9	75T060105-1011	3/16 Laminate
B-10	75T060105-1013	4.0 Diameter
B-11	75T060105-1015 #1	Damage Hole
B-12	75T060105-1015 #2	
B-13	75T060105-1017	3/16 Laminate Off-Axis
B-14	75T060105-1009	3/16 Laminate Compression
B-15	75T060106-1019	1/2 Laminate
B-16	75T060106-1021 #1	1.0 Diameter
B-17	75T060106-1021 #2	Damage Hole
B-18	75T060106-1021 #3	
B-19	75T060106-1005	1/2 Laminate
B-20	75T060106-1007 #1	2.50 Diameter
B-21	75T060106-1007 #2	Damage Hole
B-22	75T060106-1017

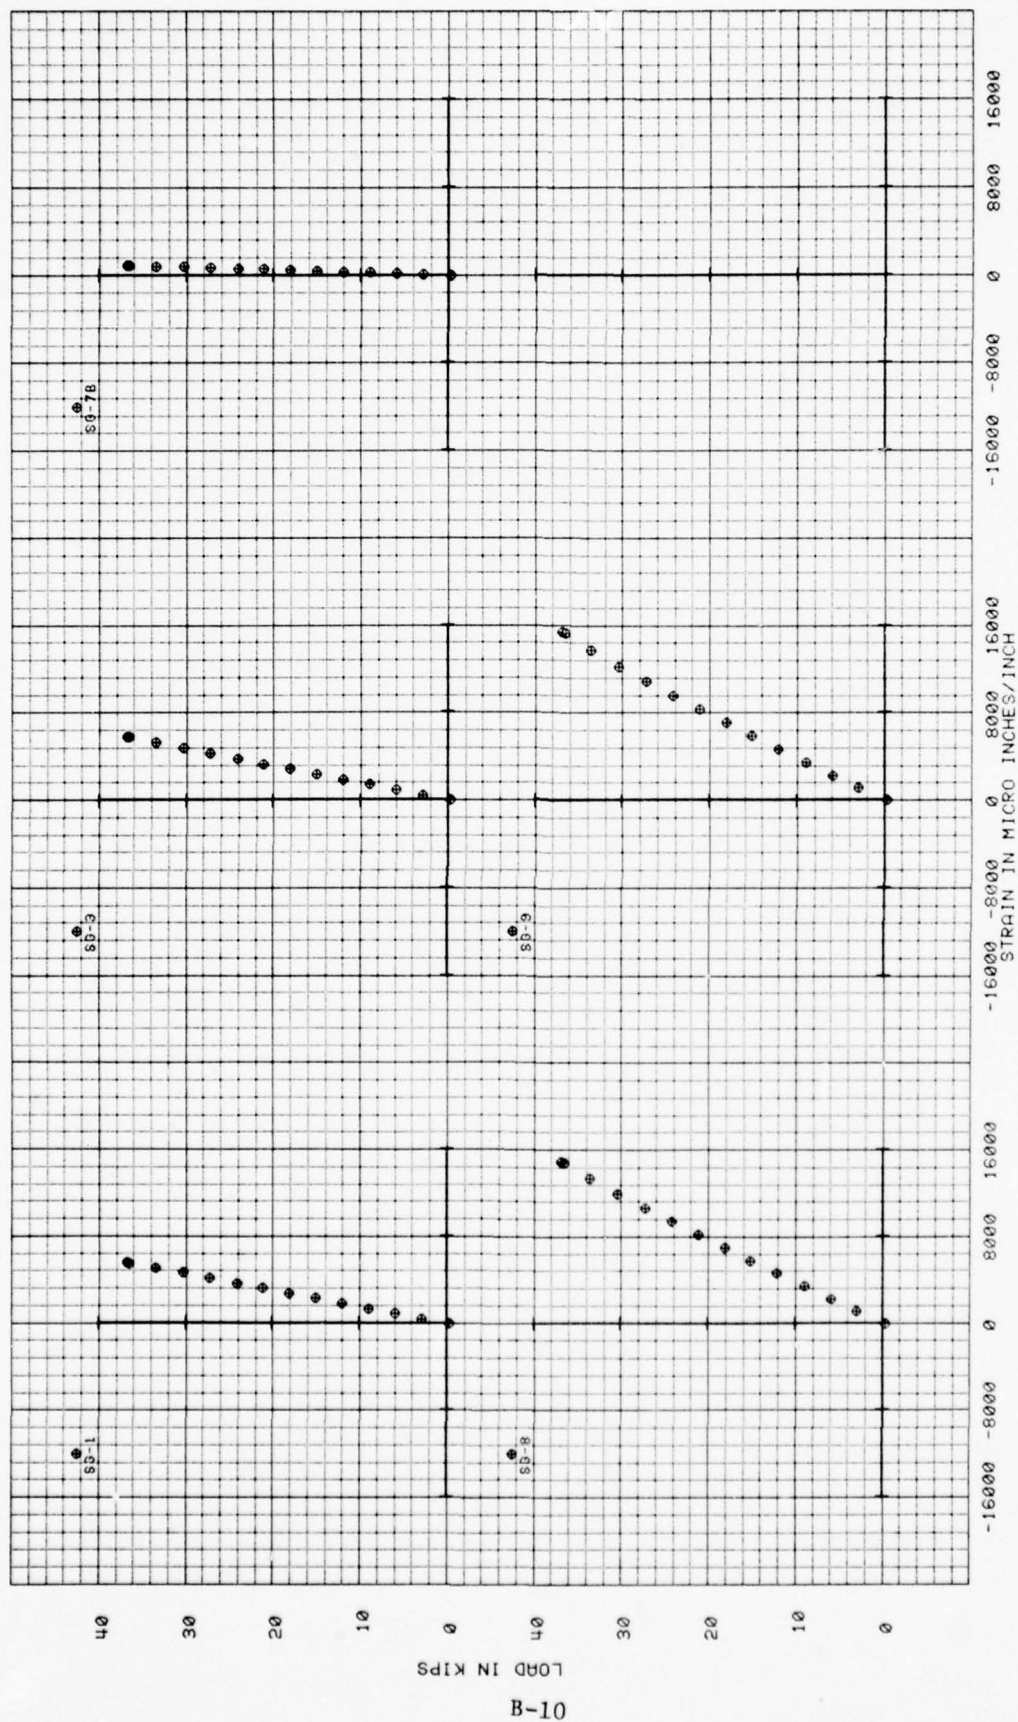
FIGURE B-3 Strain Gage Data 75T060105-1019 No. 1  
3/16 Laminate 1.0 Dia Damage Hole

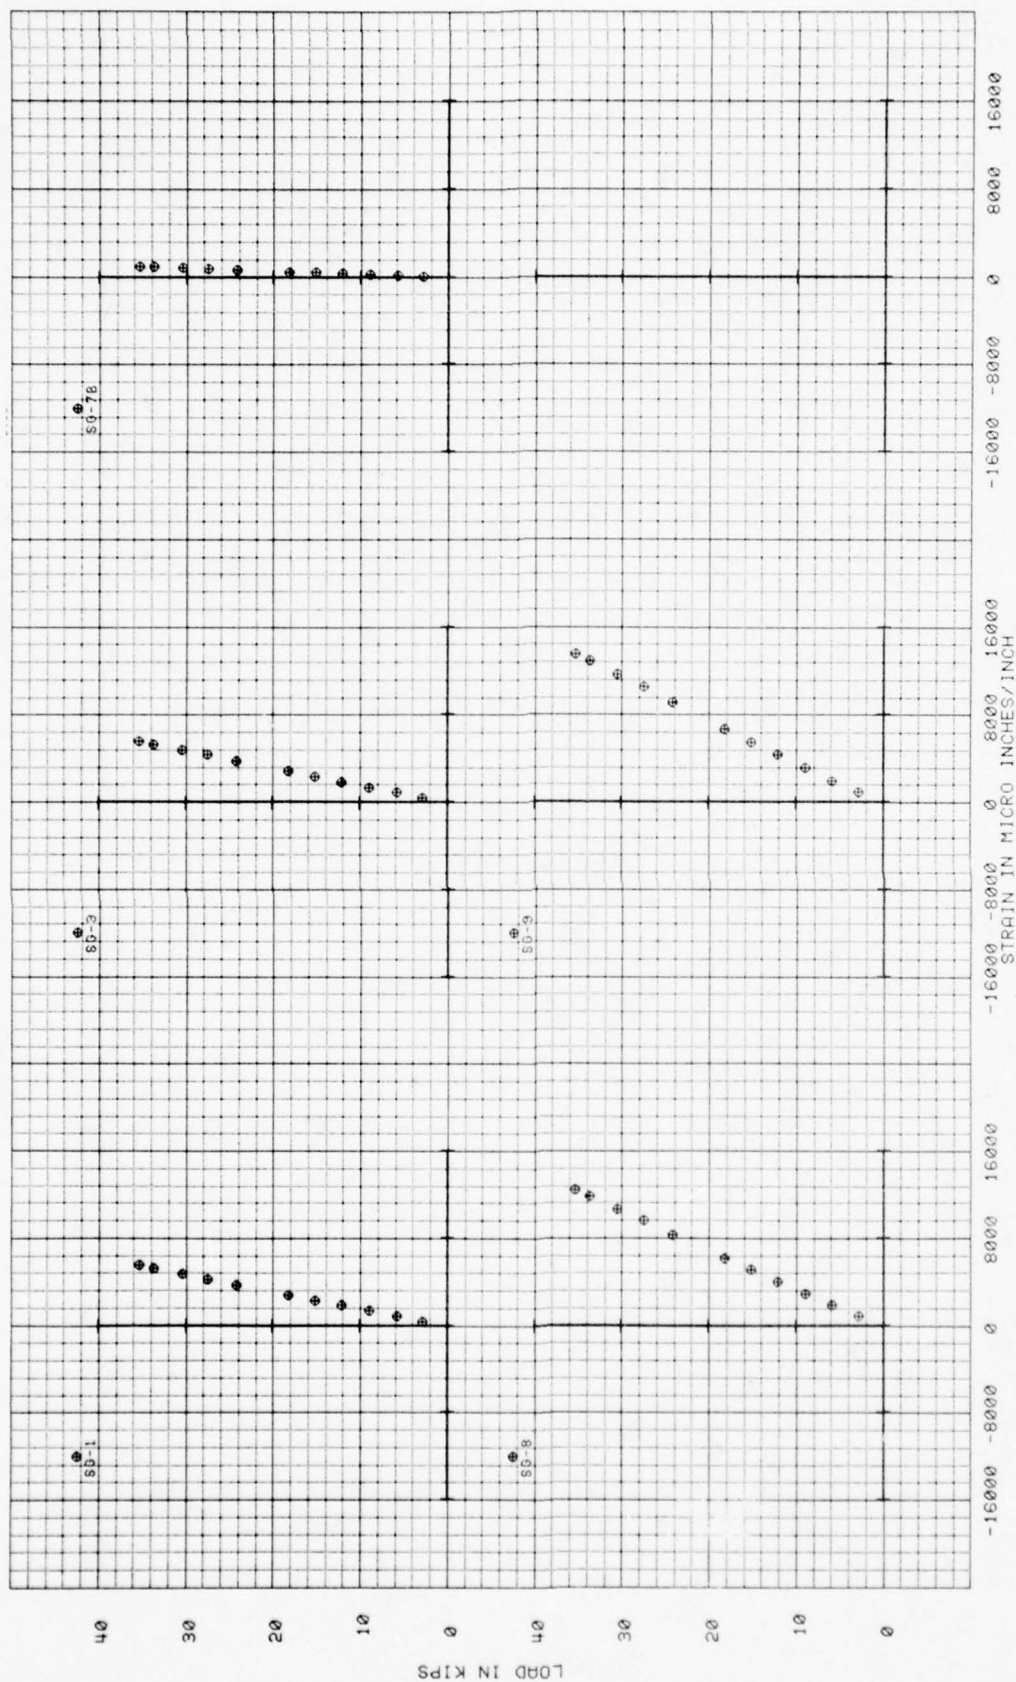
FIGURE B-4 STRAIN GAGE DATA 75T060105-1019 No. 2  
3/16 Laminate 1.0 Dia Damage Hole

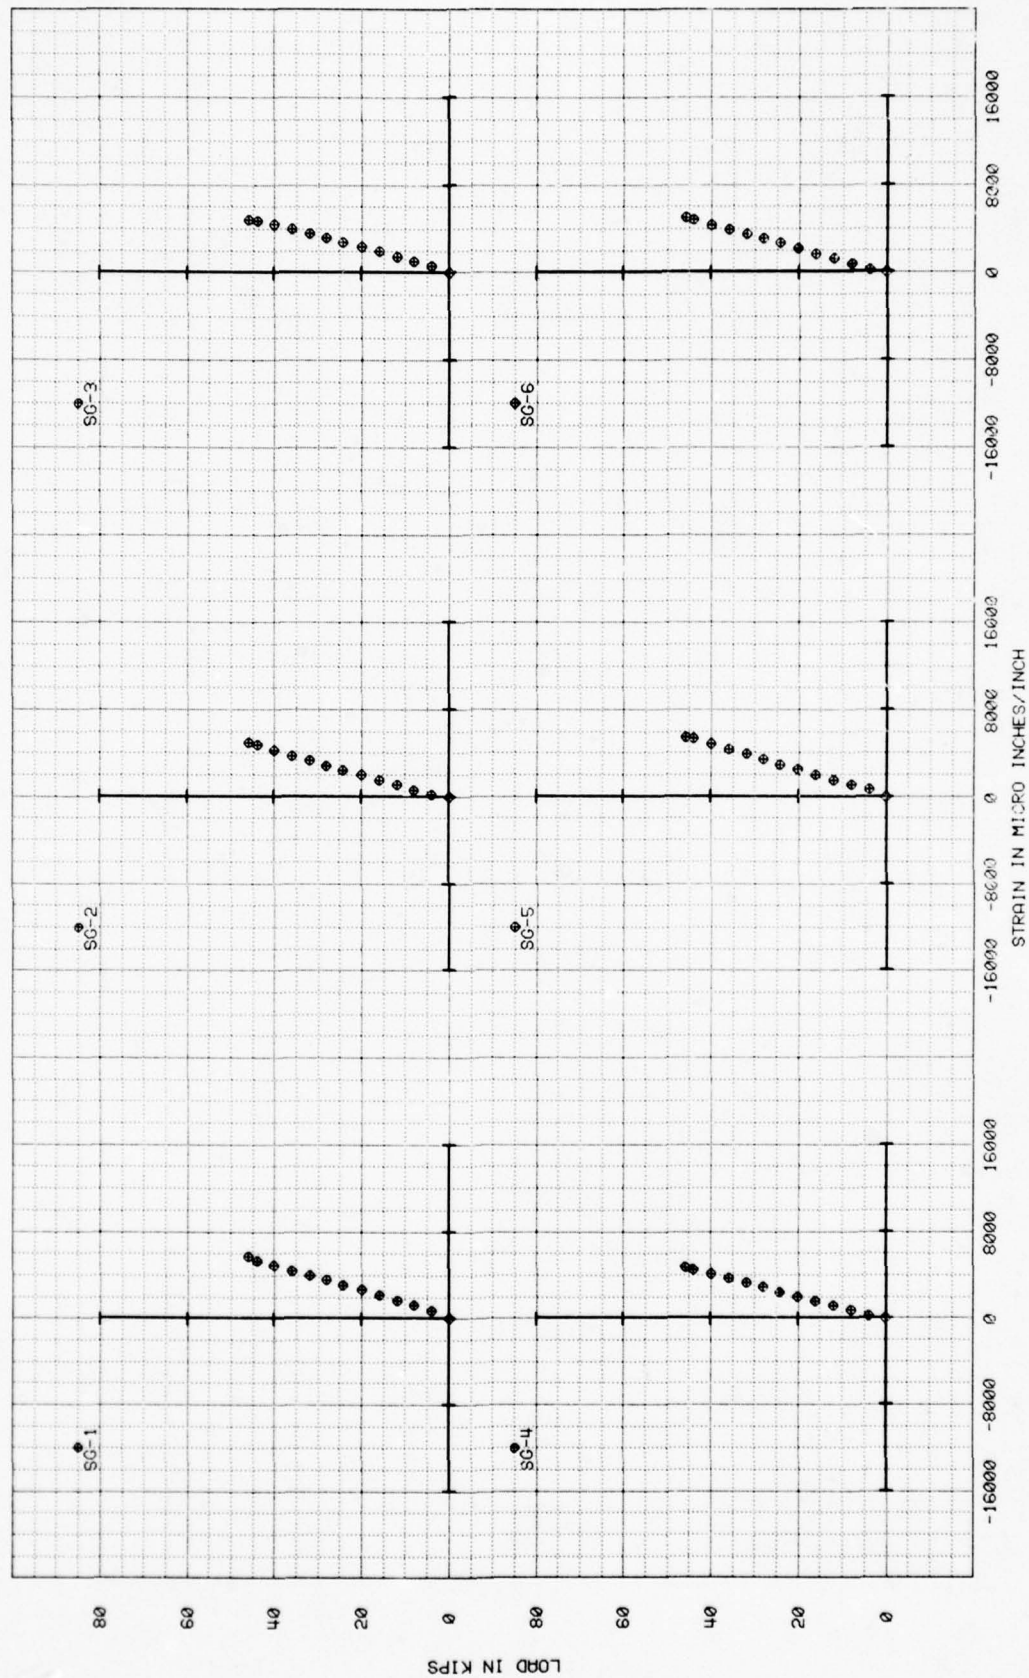
FIGURE B-5 Strain Gage Data 75T060105-1005 No. 1  
3/16 Laminate 2.5 Dia Damage Hole

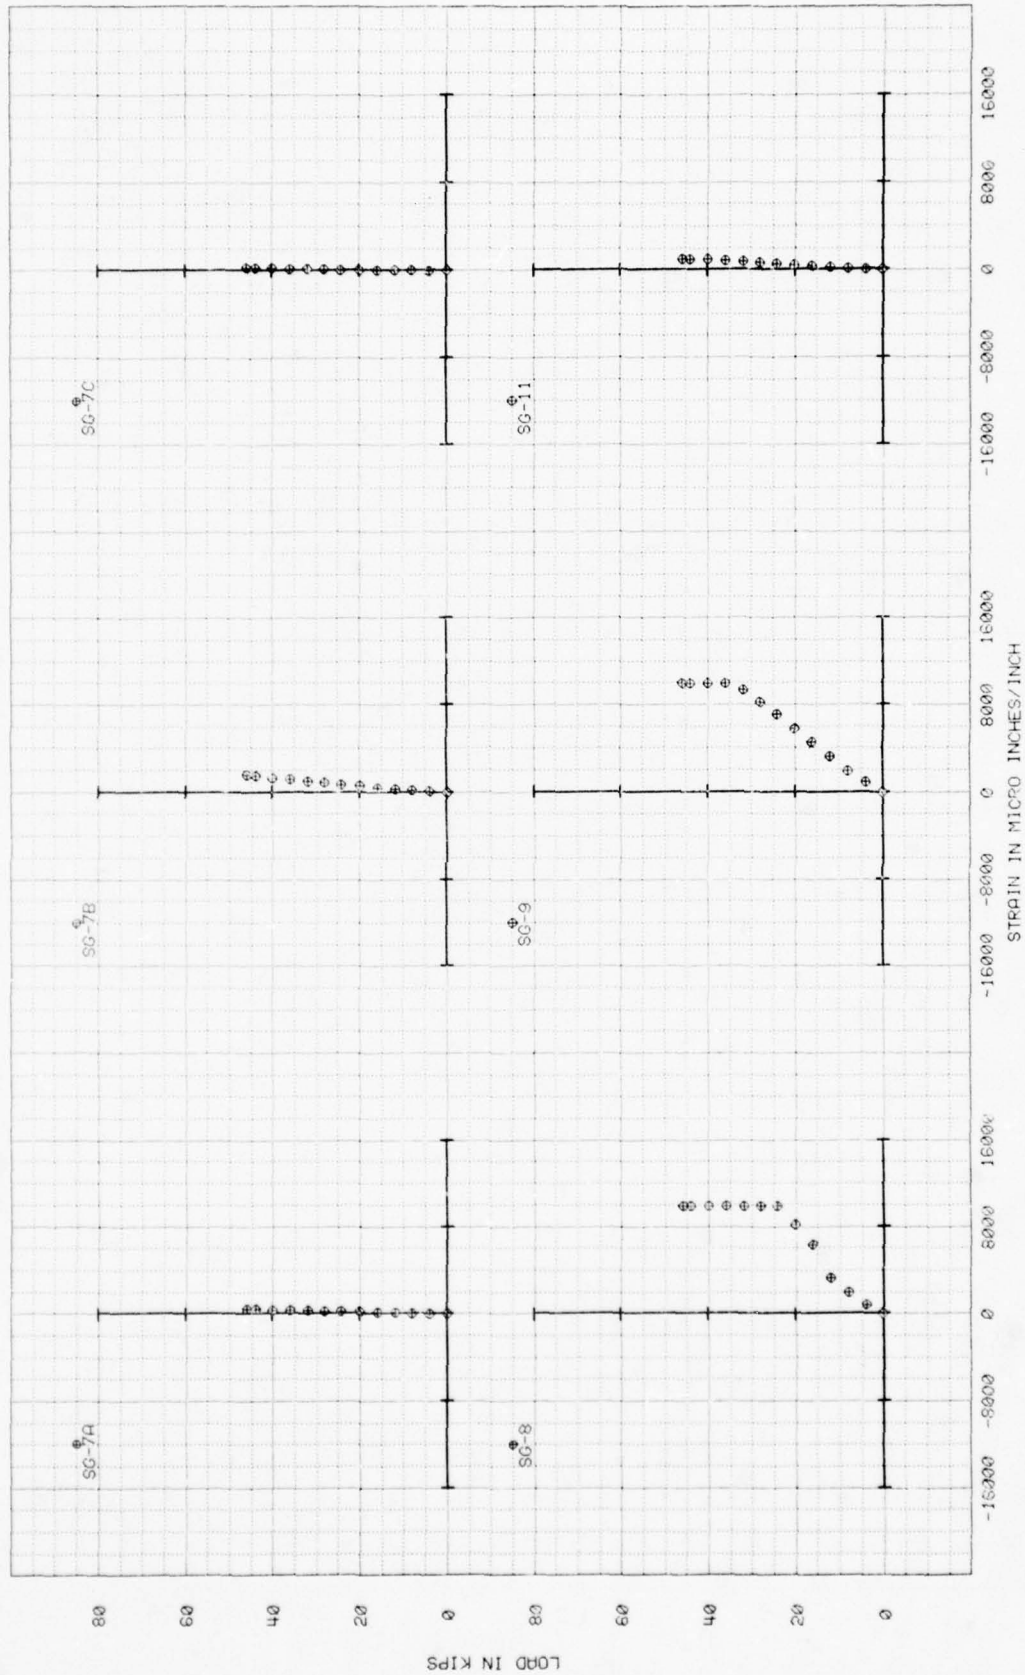
FIGURE B-5 Continued Strain Gage Data 75T060105-1005 No. 1  
3/16 Laminare 2.5 Dia Damage Hole

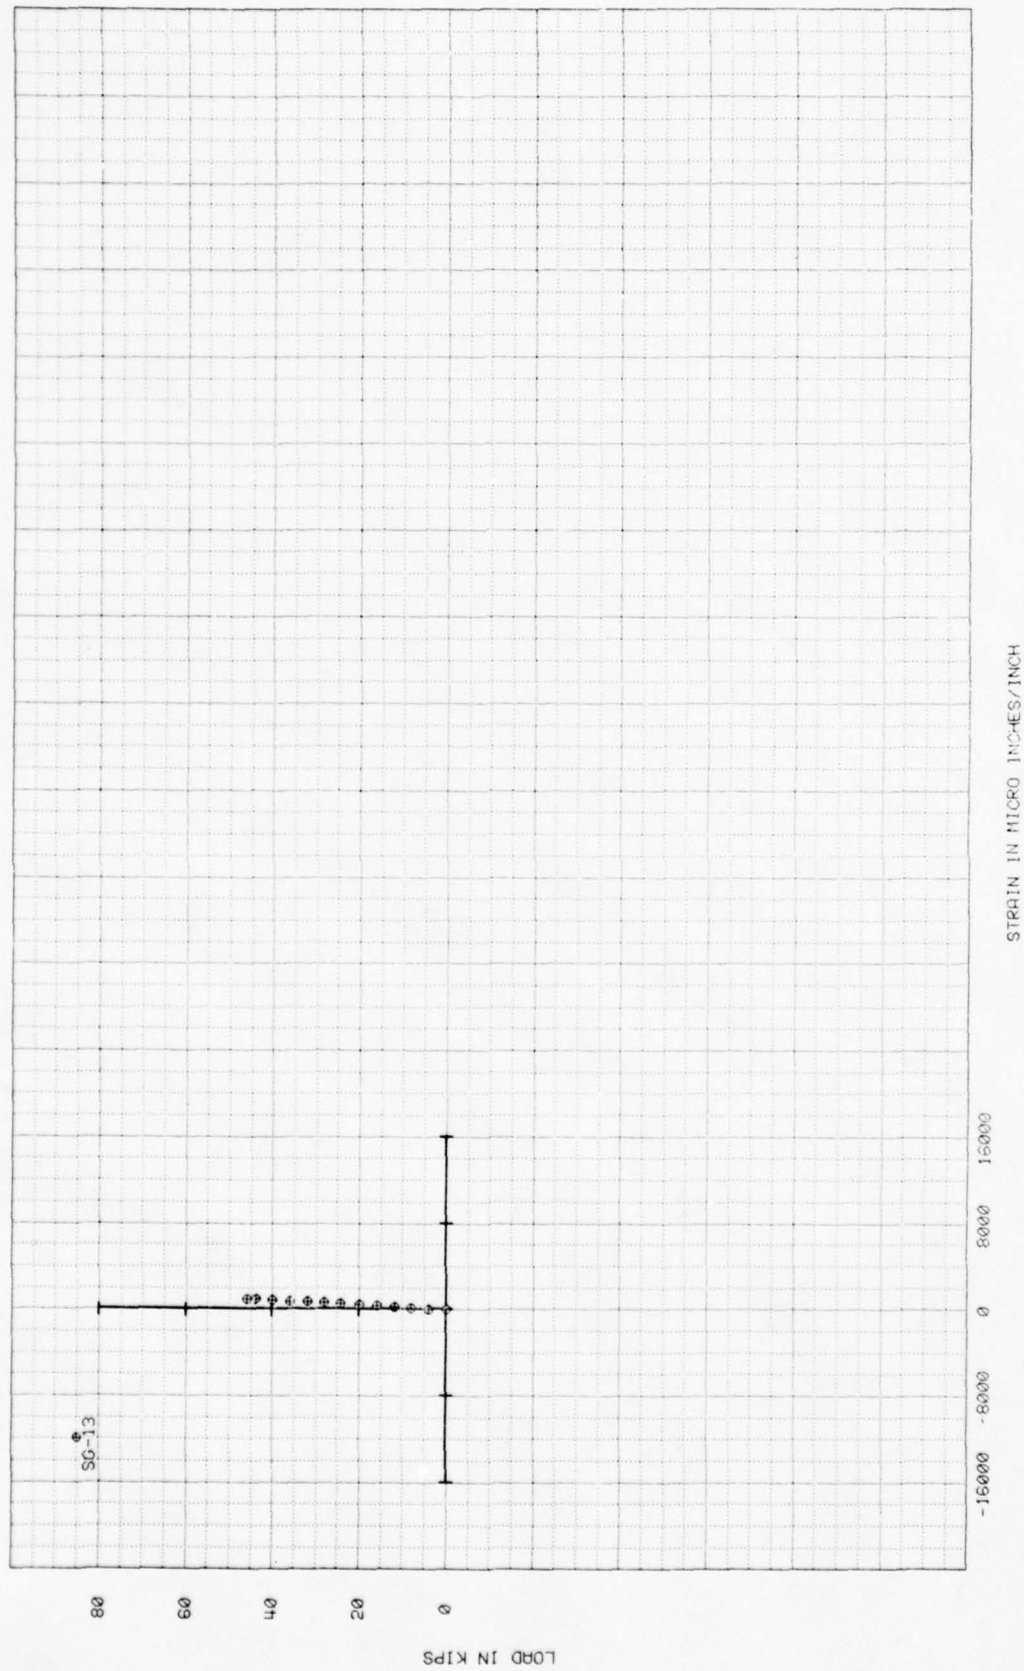
FIGURE B-5 Continued Strain Gage Data 75T060105-1005 No. 1  
3/16 Laminated 2.5 Dia Damage Hole

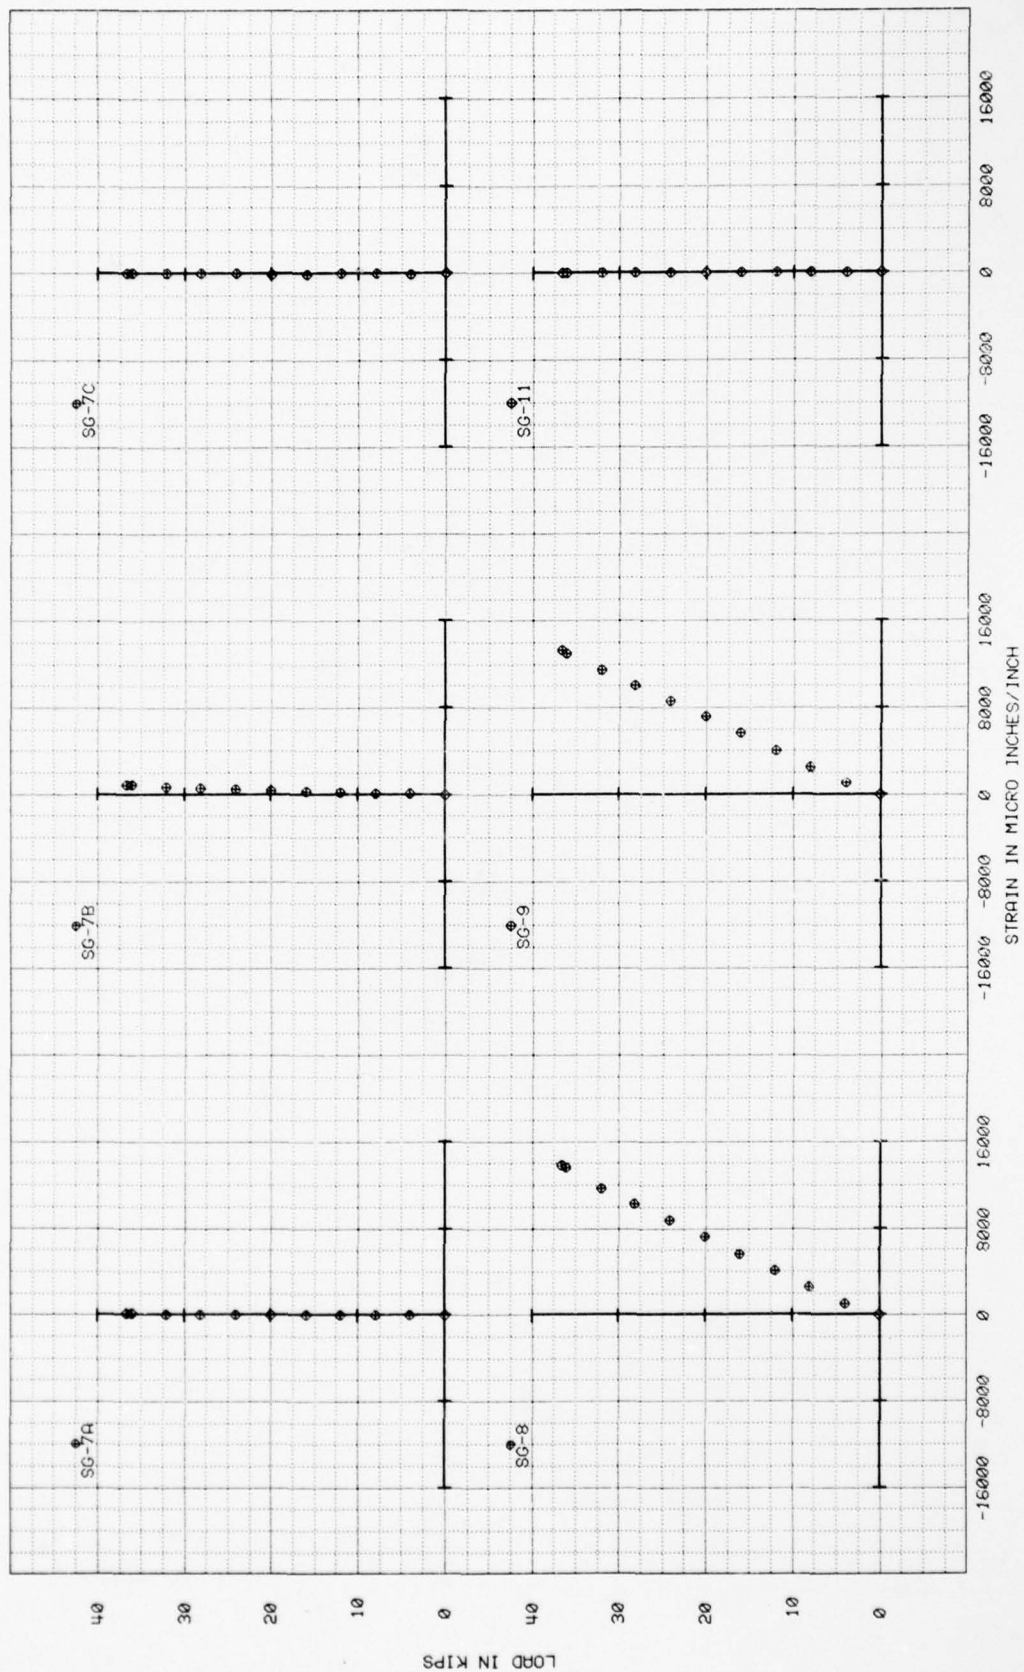
FIGURE B-6 Continued Strain Gage Data 75T060105-1007  
3/16 Laminated 2.5 Dia Damage Hole

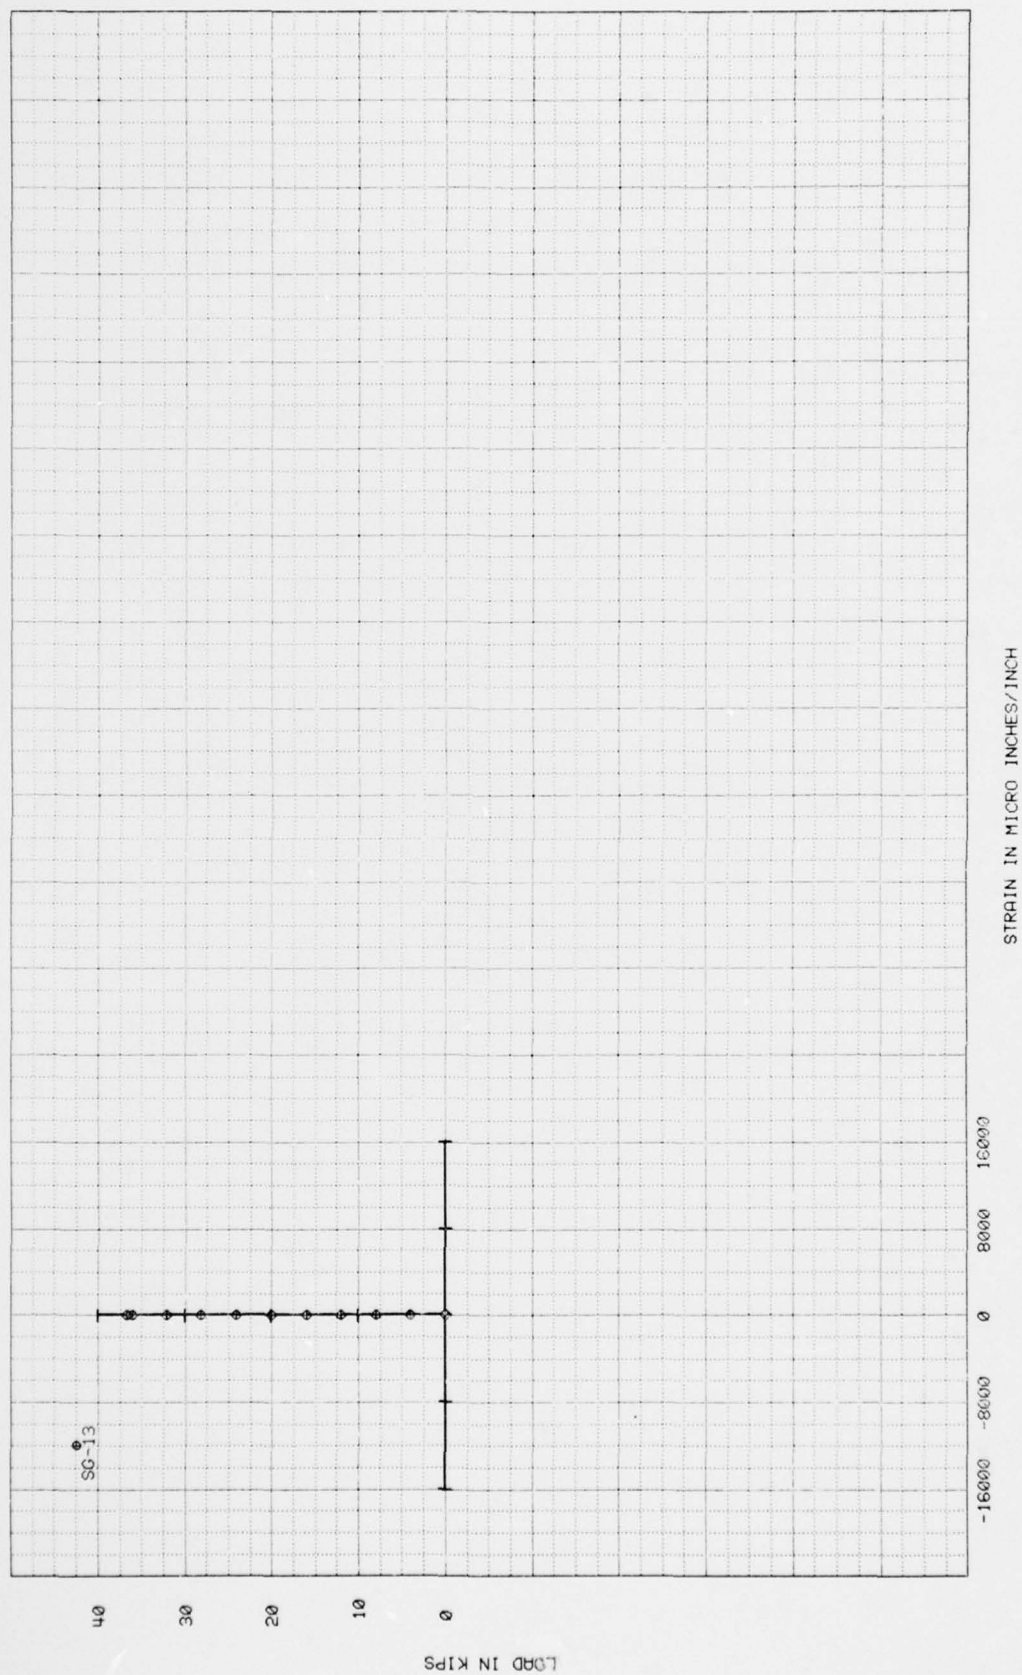
FIGURE B-6 Continued Strain Gage Data 75T060105-1007  
3/16 Laminated 2.5 Dia Damage Hole

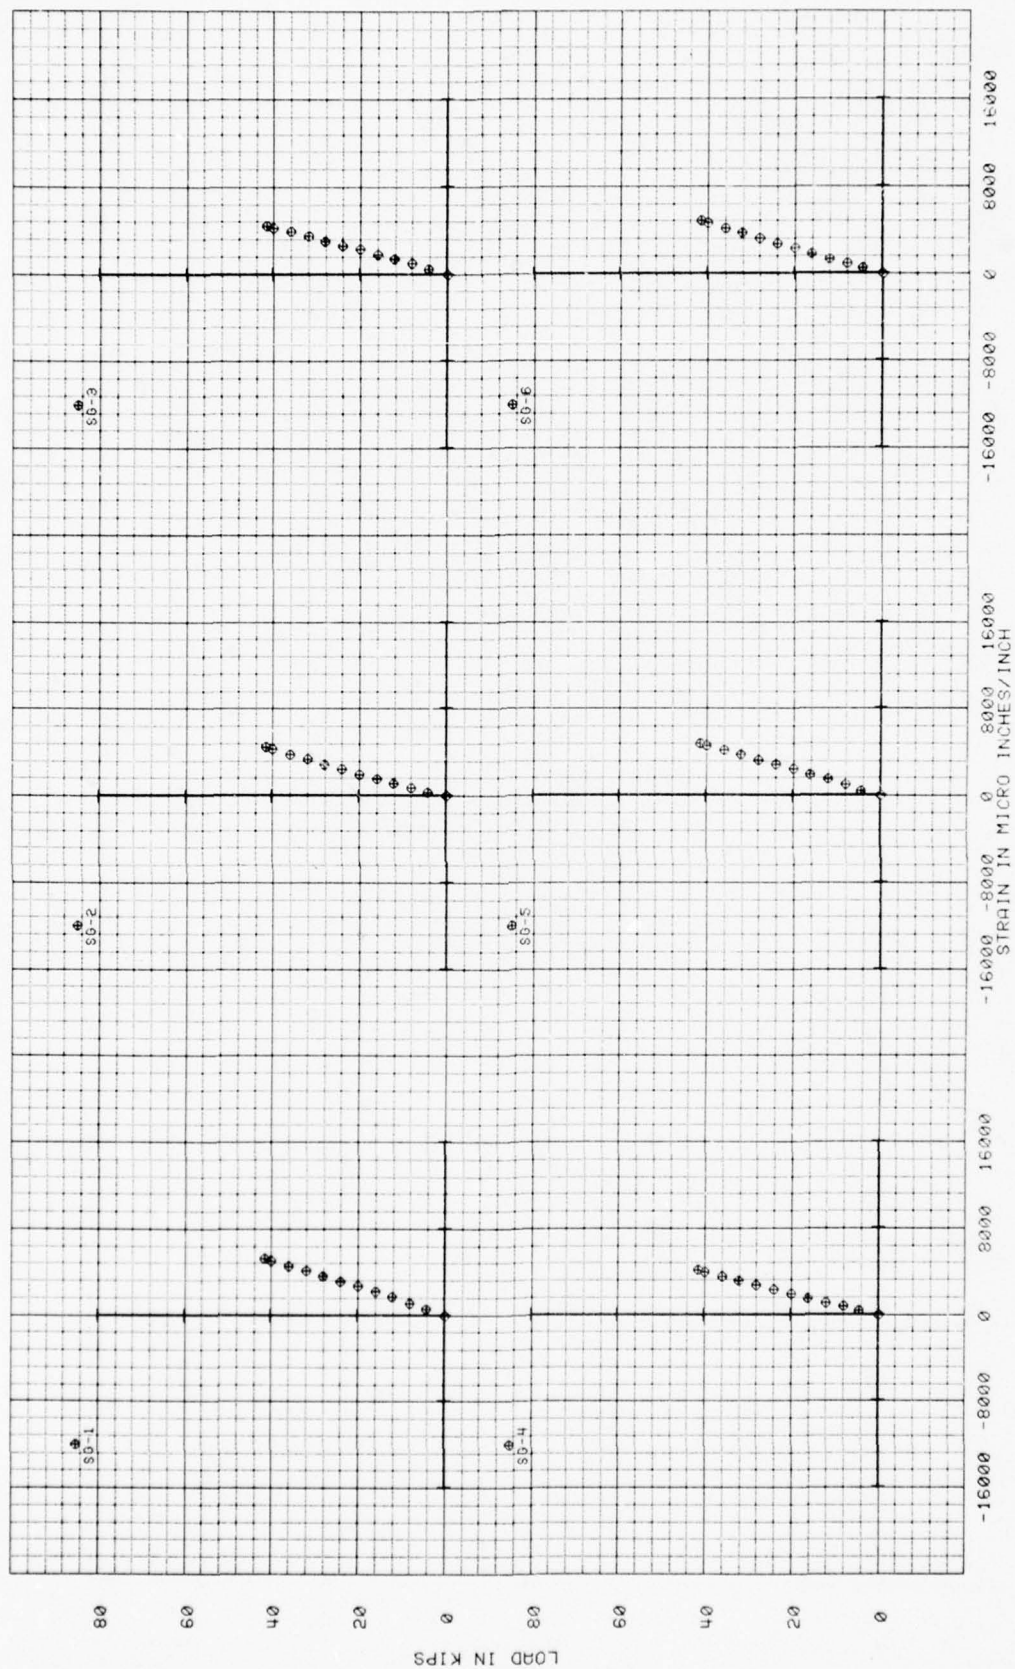
FIGURE B-7 Strain Gage Data 75T060105-1005 No. 2  
3/16 Laminare 2.5 Dia Damage Hole

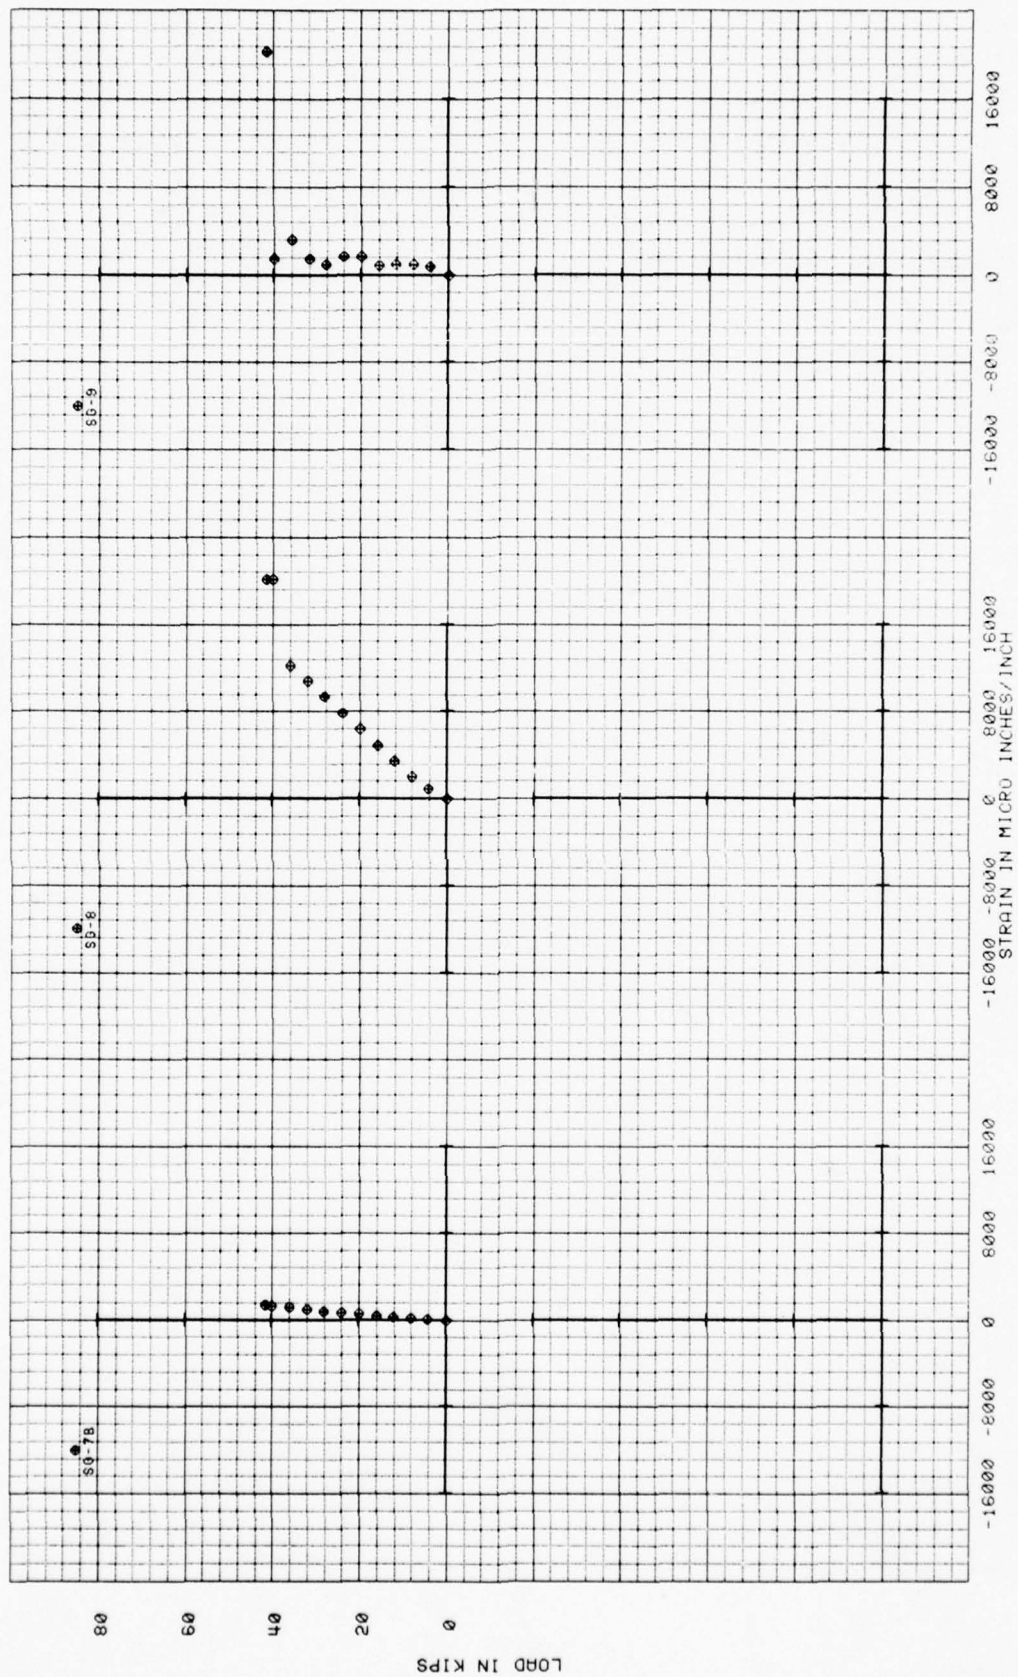
FIGURE B-7 Continued Strain Gage Data 75T060105-1005 No. 2  
3/16 Laminated 2.5 Dia Damage Hole

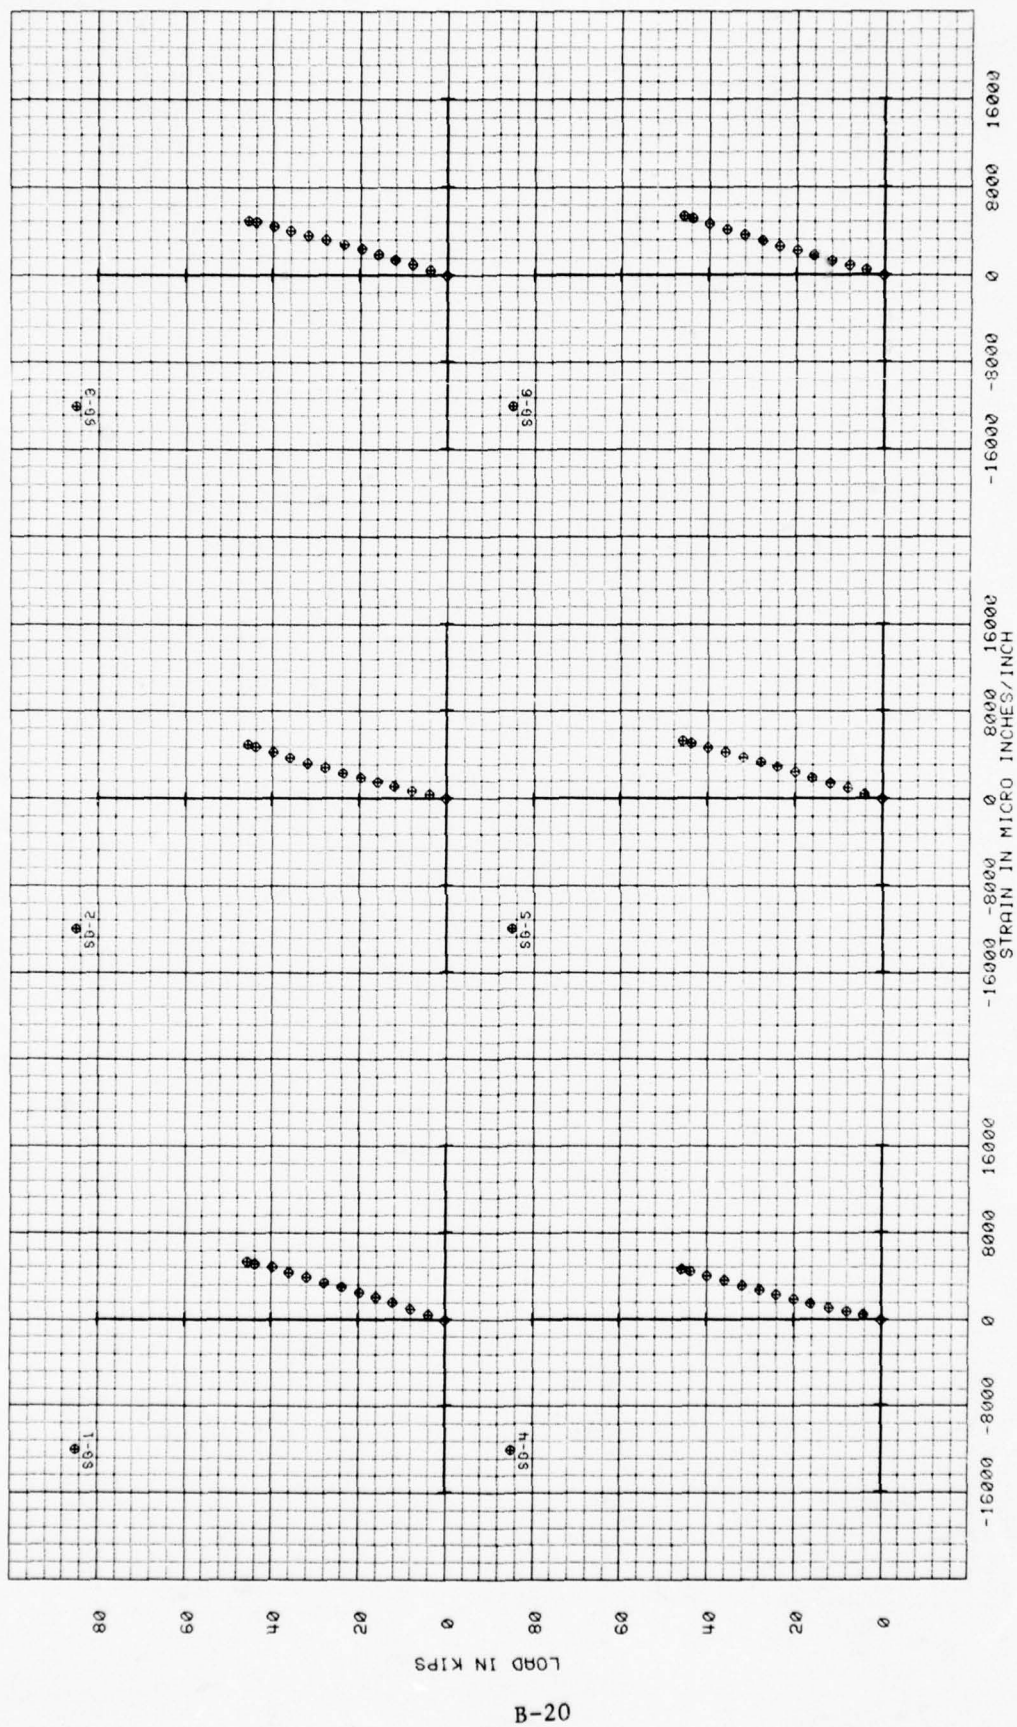
FIGURE B-8 Strain Gage Data 75T060105-1005 No. 3  
3/16 Laminated 2.5 Dia Damage Hole
